US 90 Arterial Study: Vulnerable Road Users

US 90 from the Escambia County Line to
SR 87 South in Santa Rosa County, Florida

FPID: 418439-1-32-06

Submitted by:
Jacobs Engineering Group, Inc.
June 6, 2014

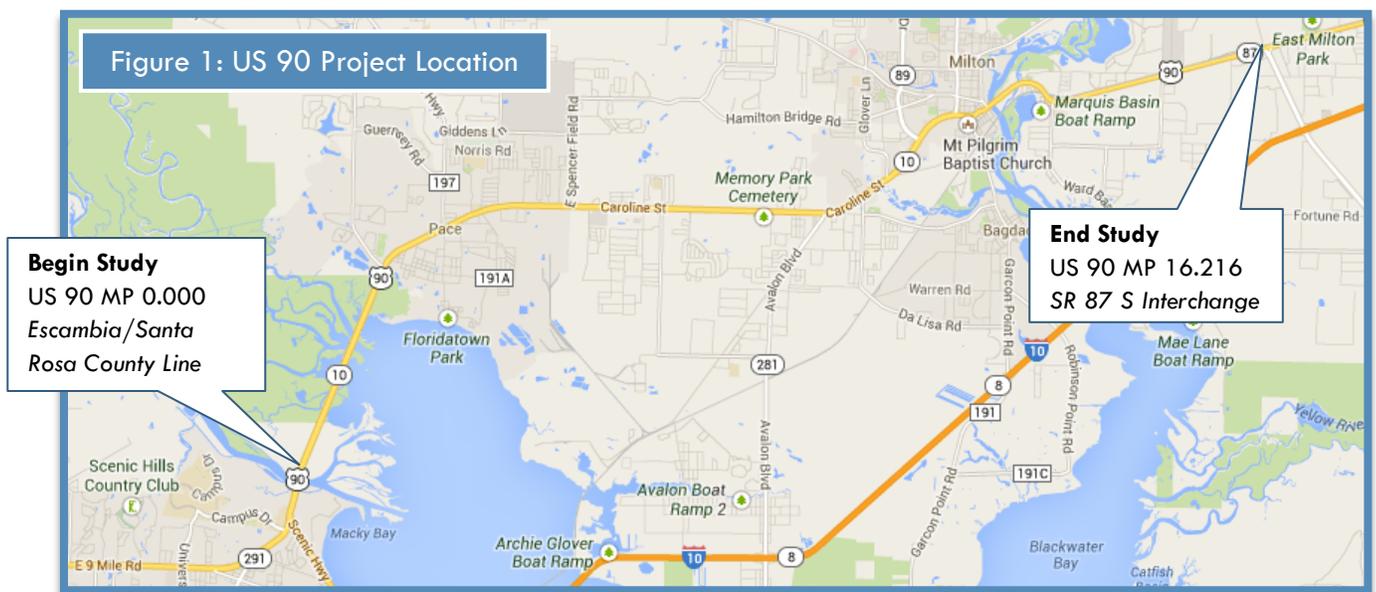
Figure 1 US 90 Project Location

The objective of this Arterial Study is to summarize safety analysis results and recommended improvements along US 90, with a focus on vulnerable road users (VRUs). The corridor lies in Santa Rosa County, Florida, extending 16.2 miles from the Escambia County Line to State Road (SR) 87 South, as illustrated in Figure 1. This document first presents a broad engineering assessment of existing site conditions, lighting features, safety measures, recent crash history, and areas of critical concern. Corresponding recommendations are provided for safety concerns identified in the preliminary analysis phase. Additionally, local stakeholder input is presented and addressed with further safety recommendations as applicable.

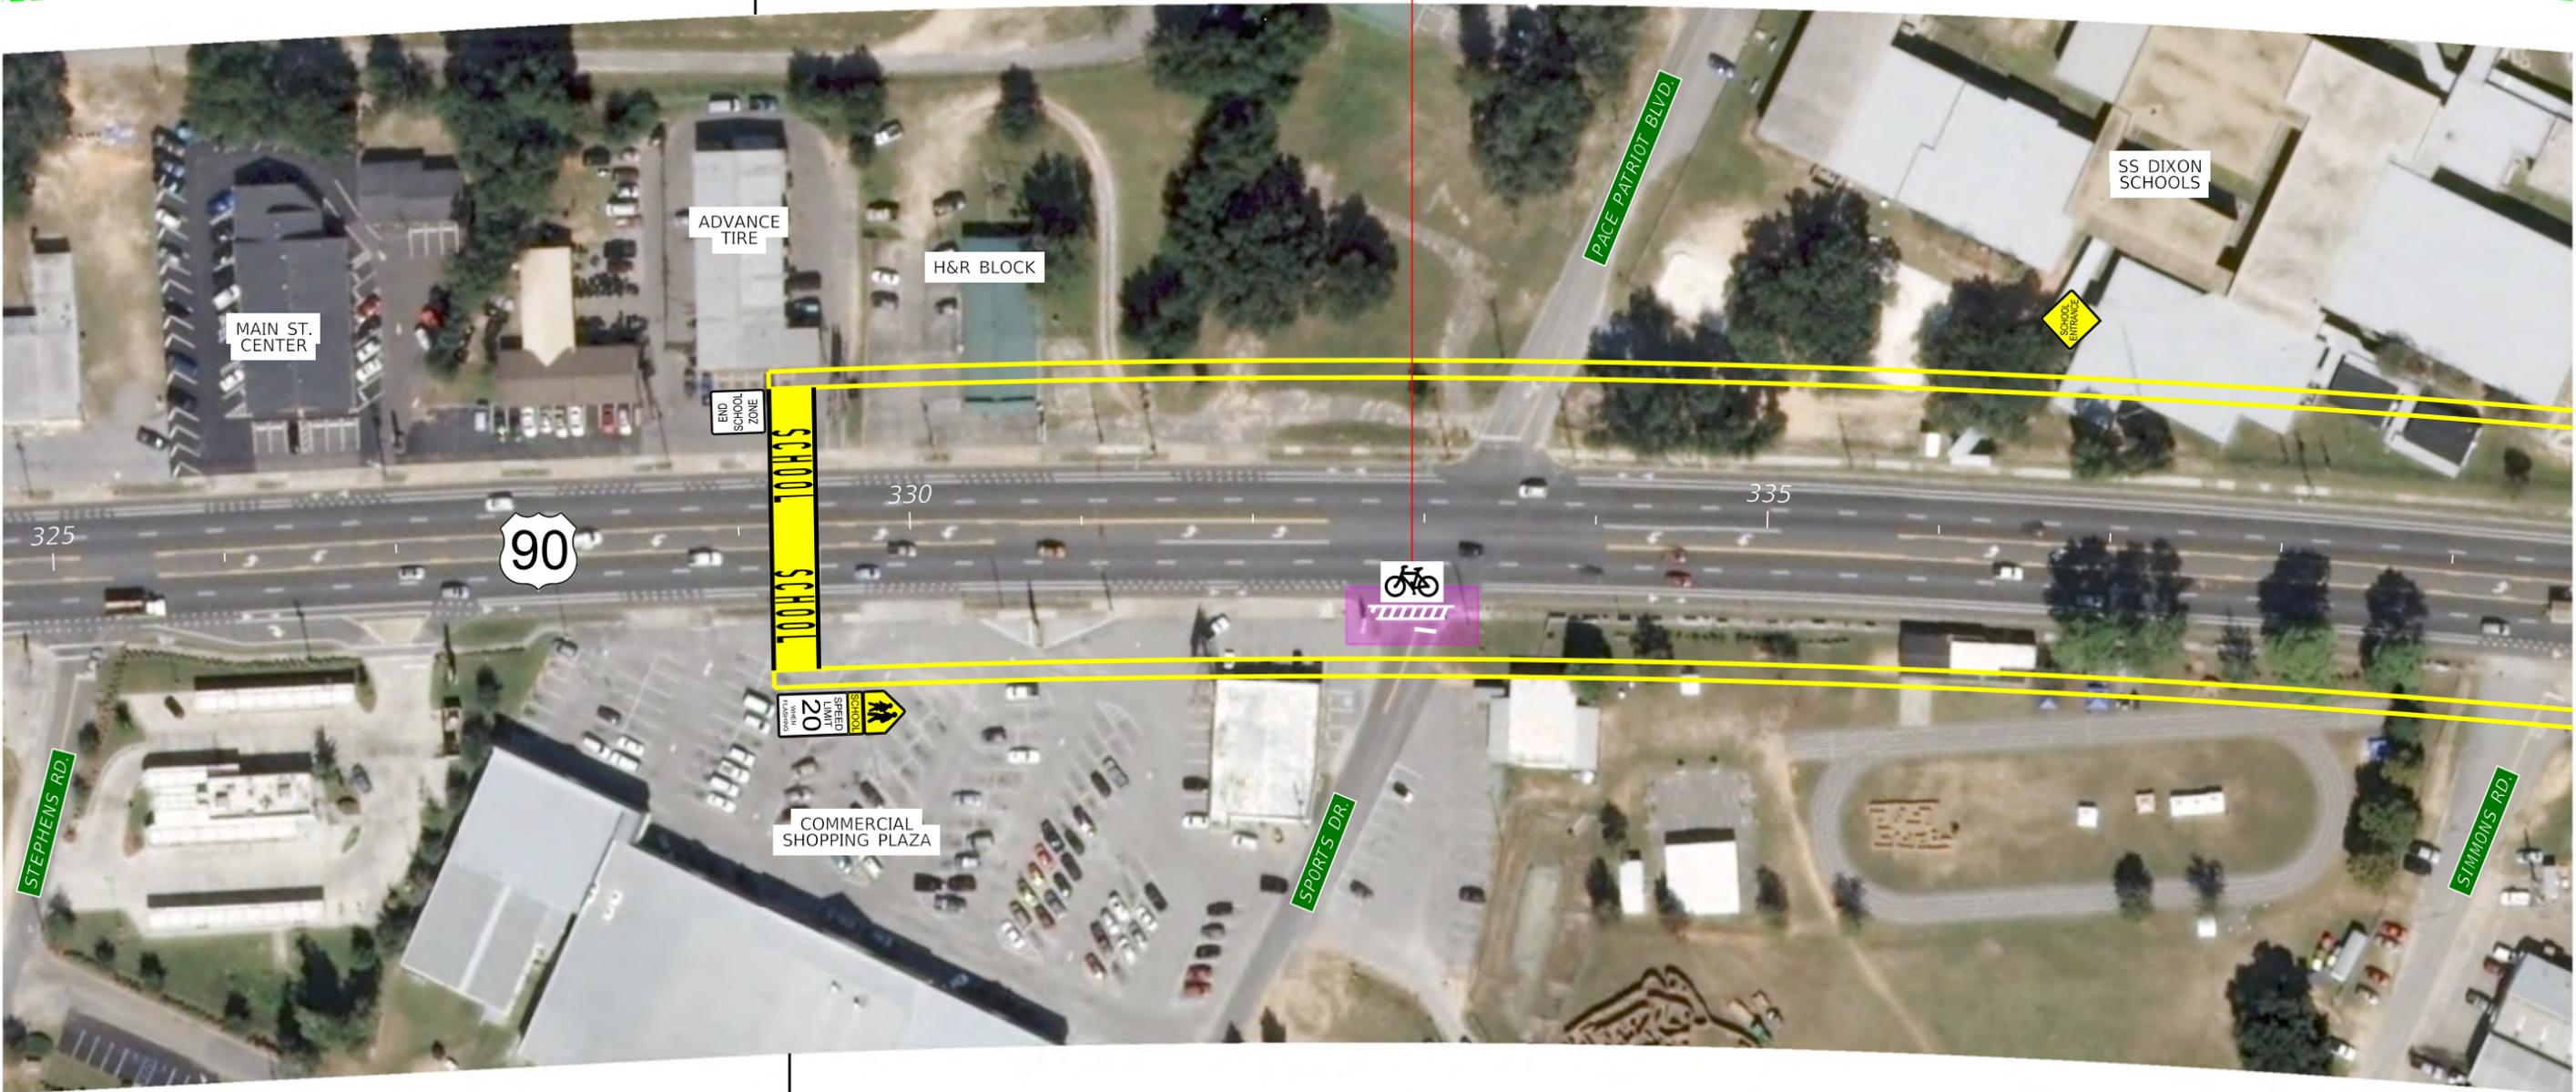
P2: Bicyclist using sidewalk (not bike lane) struck by vehicle while crossing Sports Dr along EB US 90

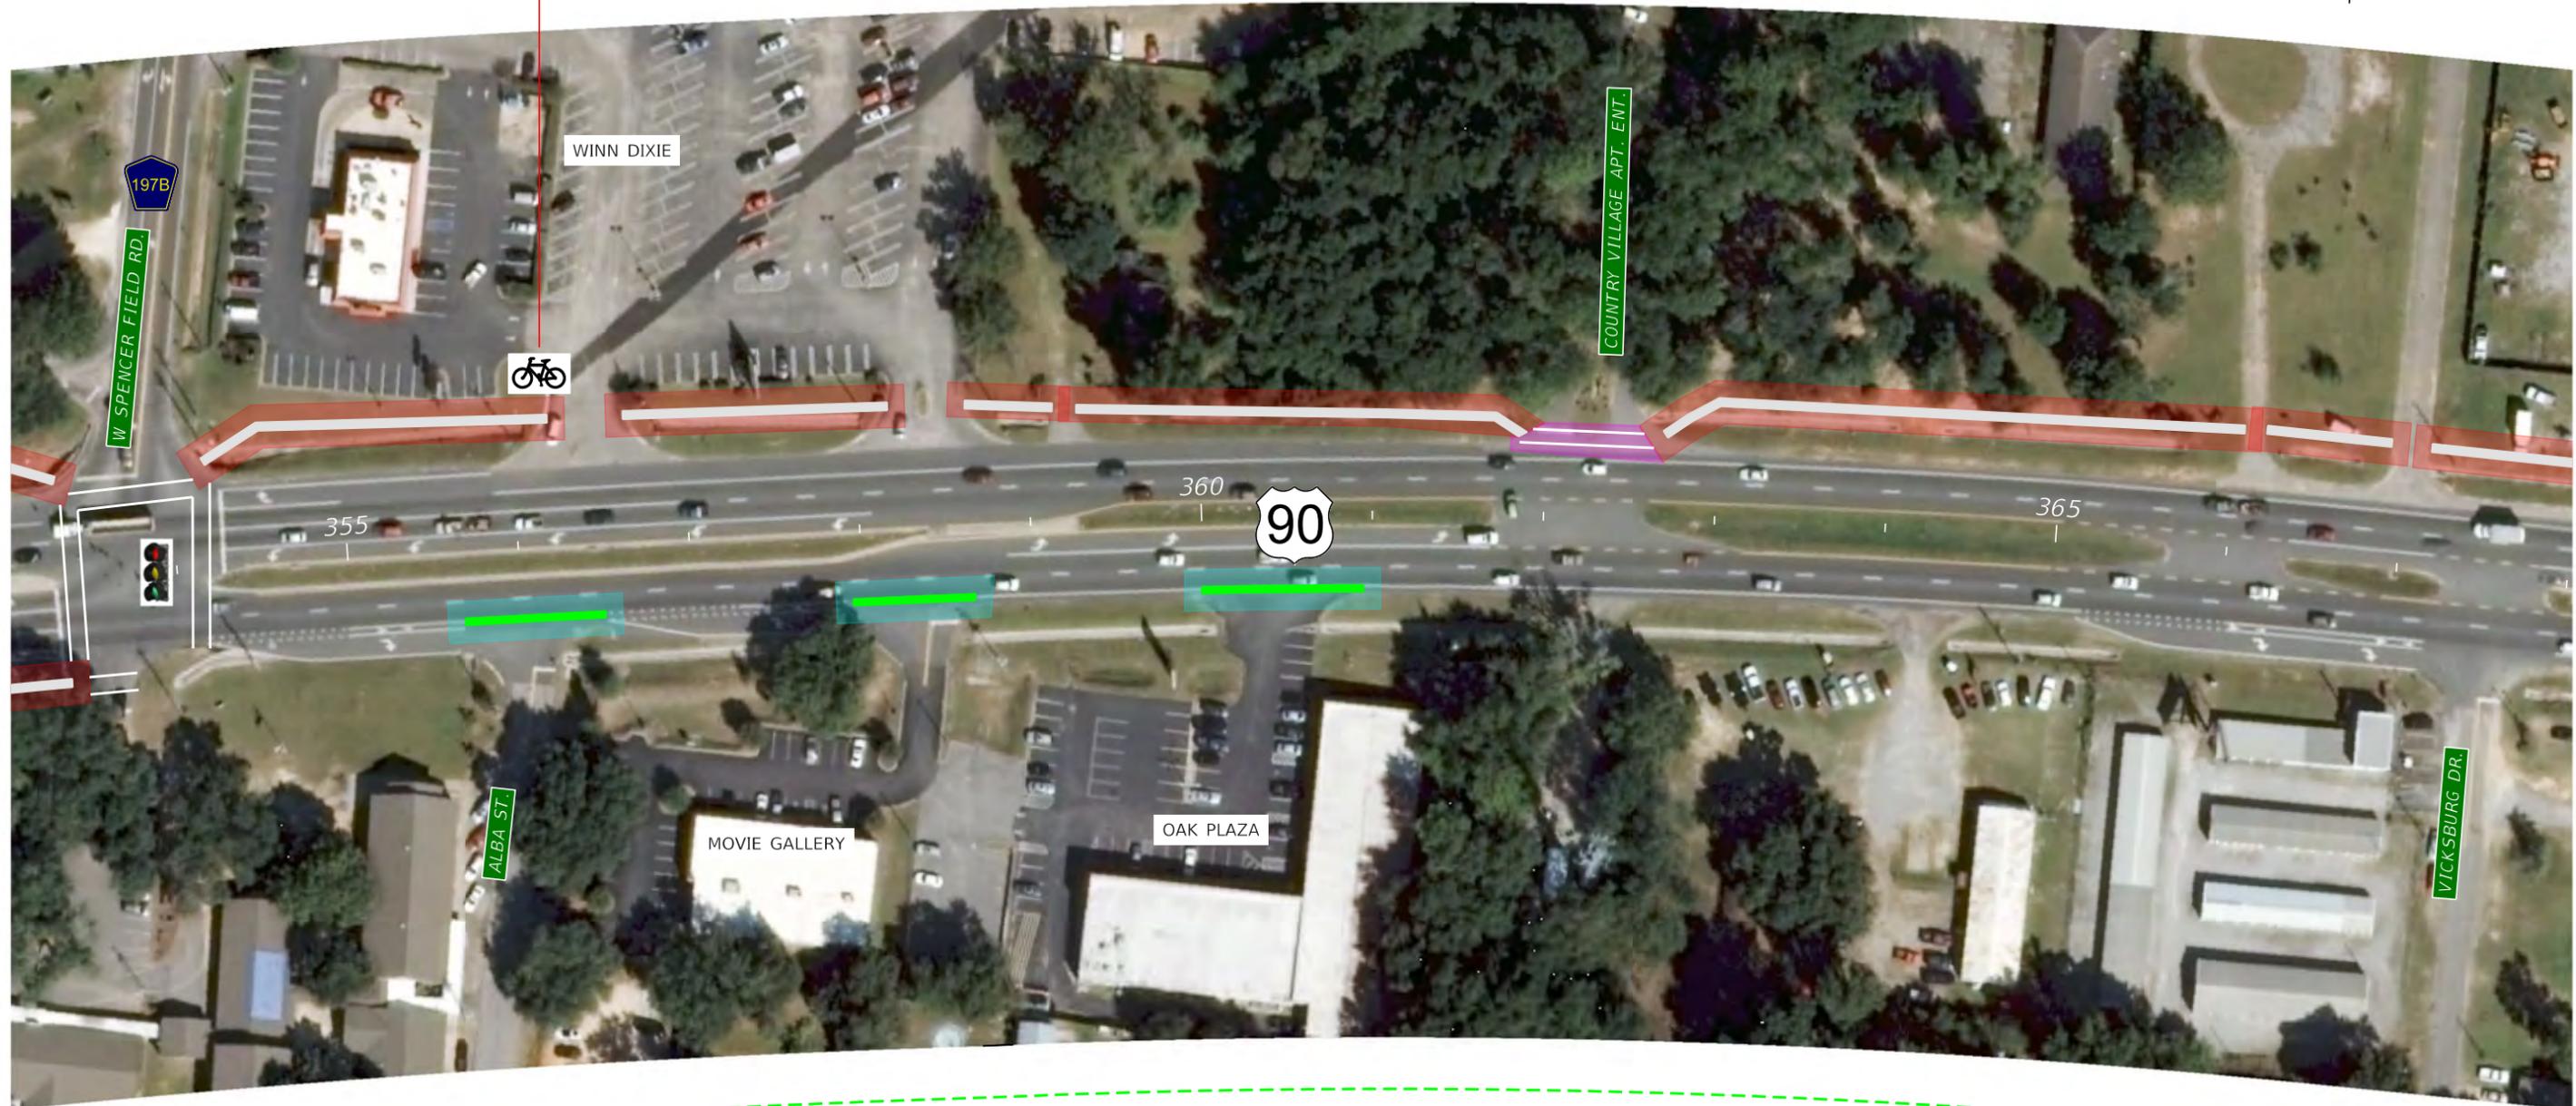
P3: Bicyclist exiting Winn Dixie parking lot entered turn lane into path of WB vehicle

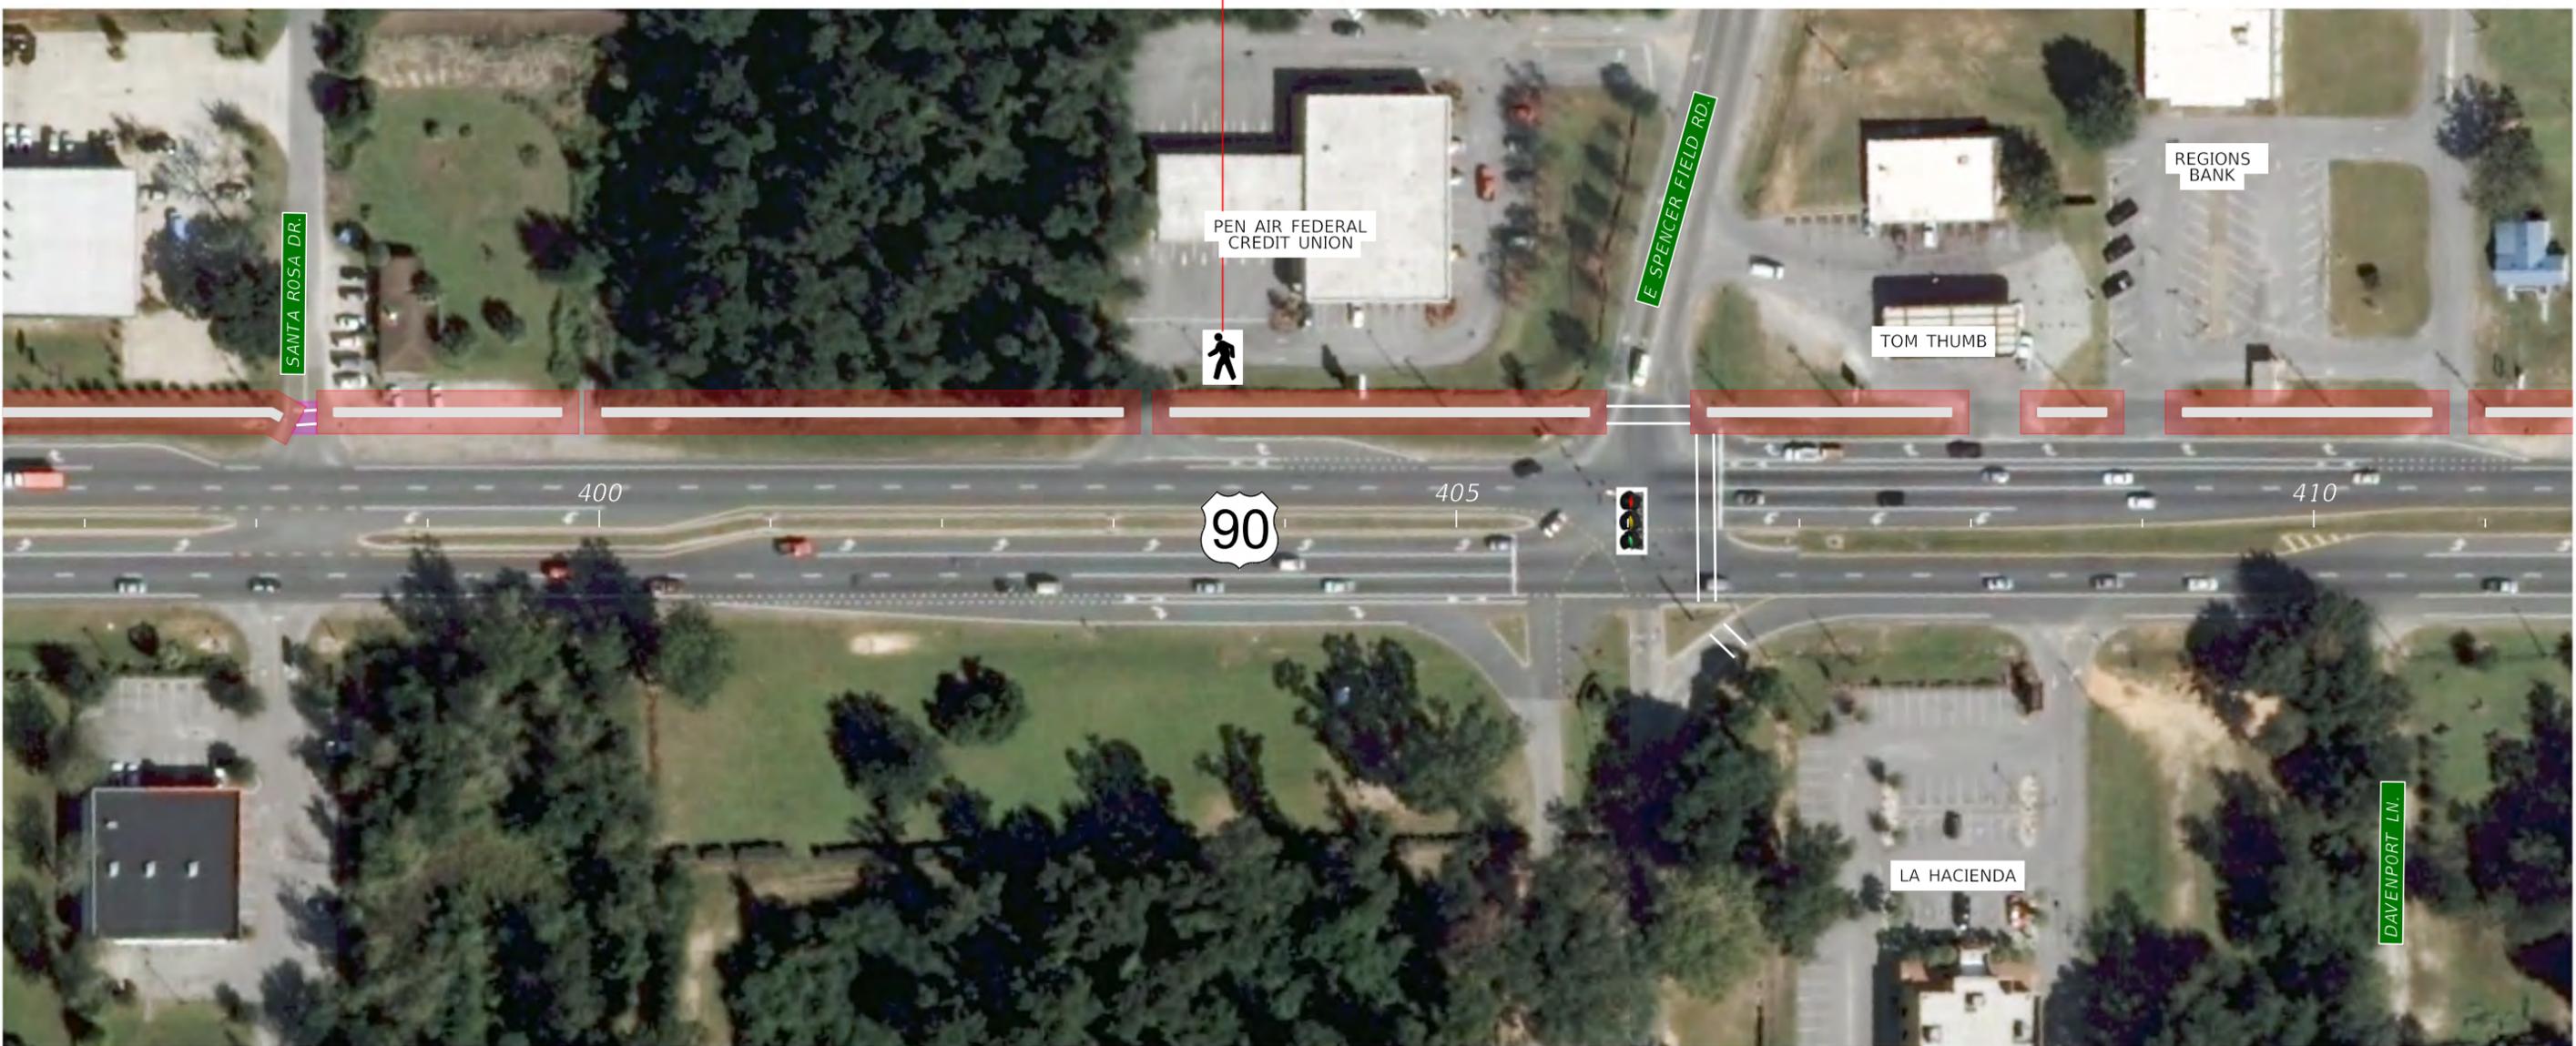
P4: Pedestrian in roadway struck by passing WB vehicle mirror near E Spencer Field Rd

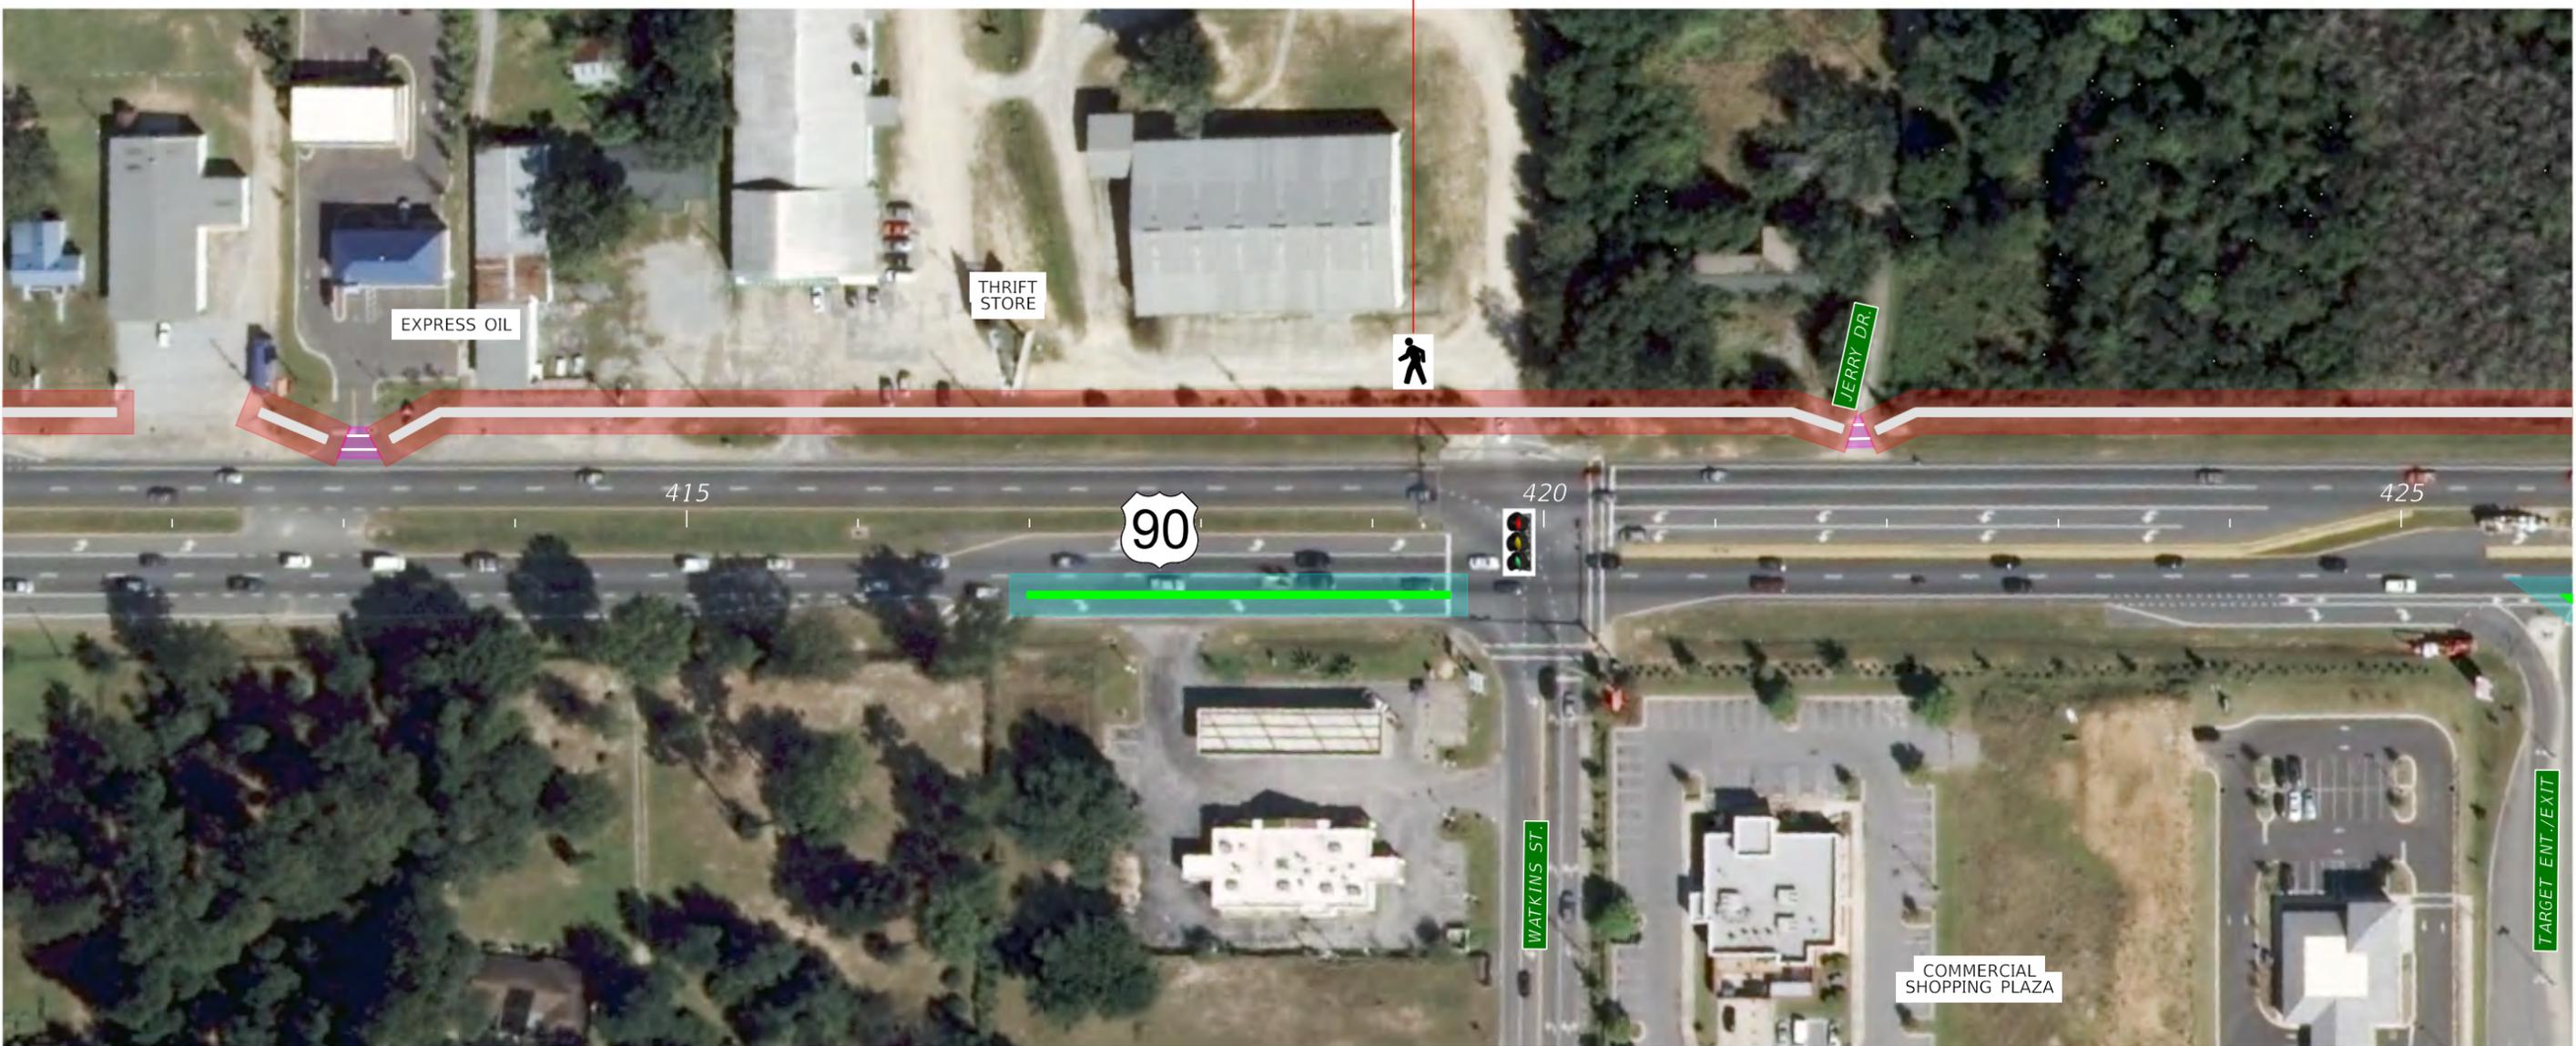
P5: Pedestrian walking in bike lane struck by passing WB vehicle near Watkins St

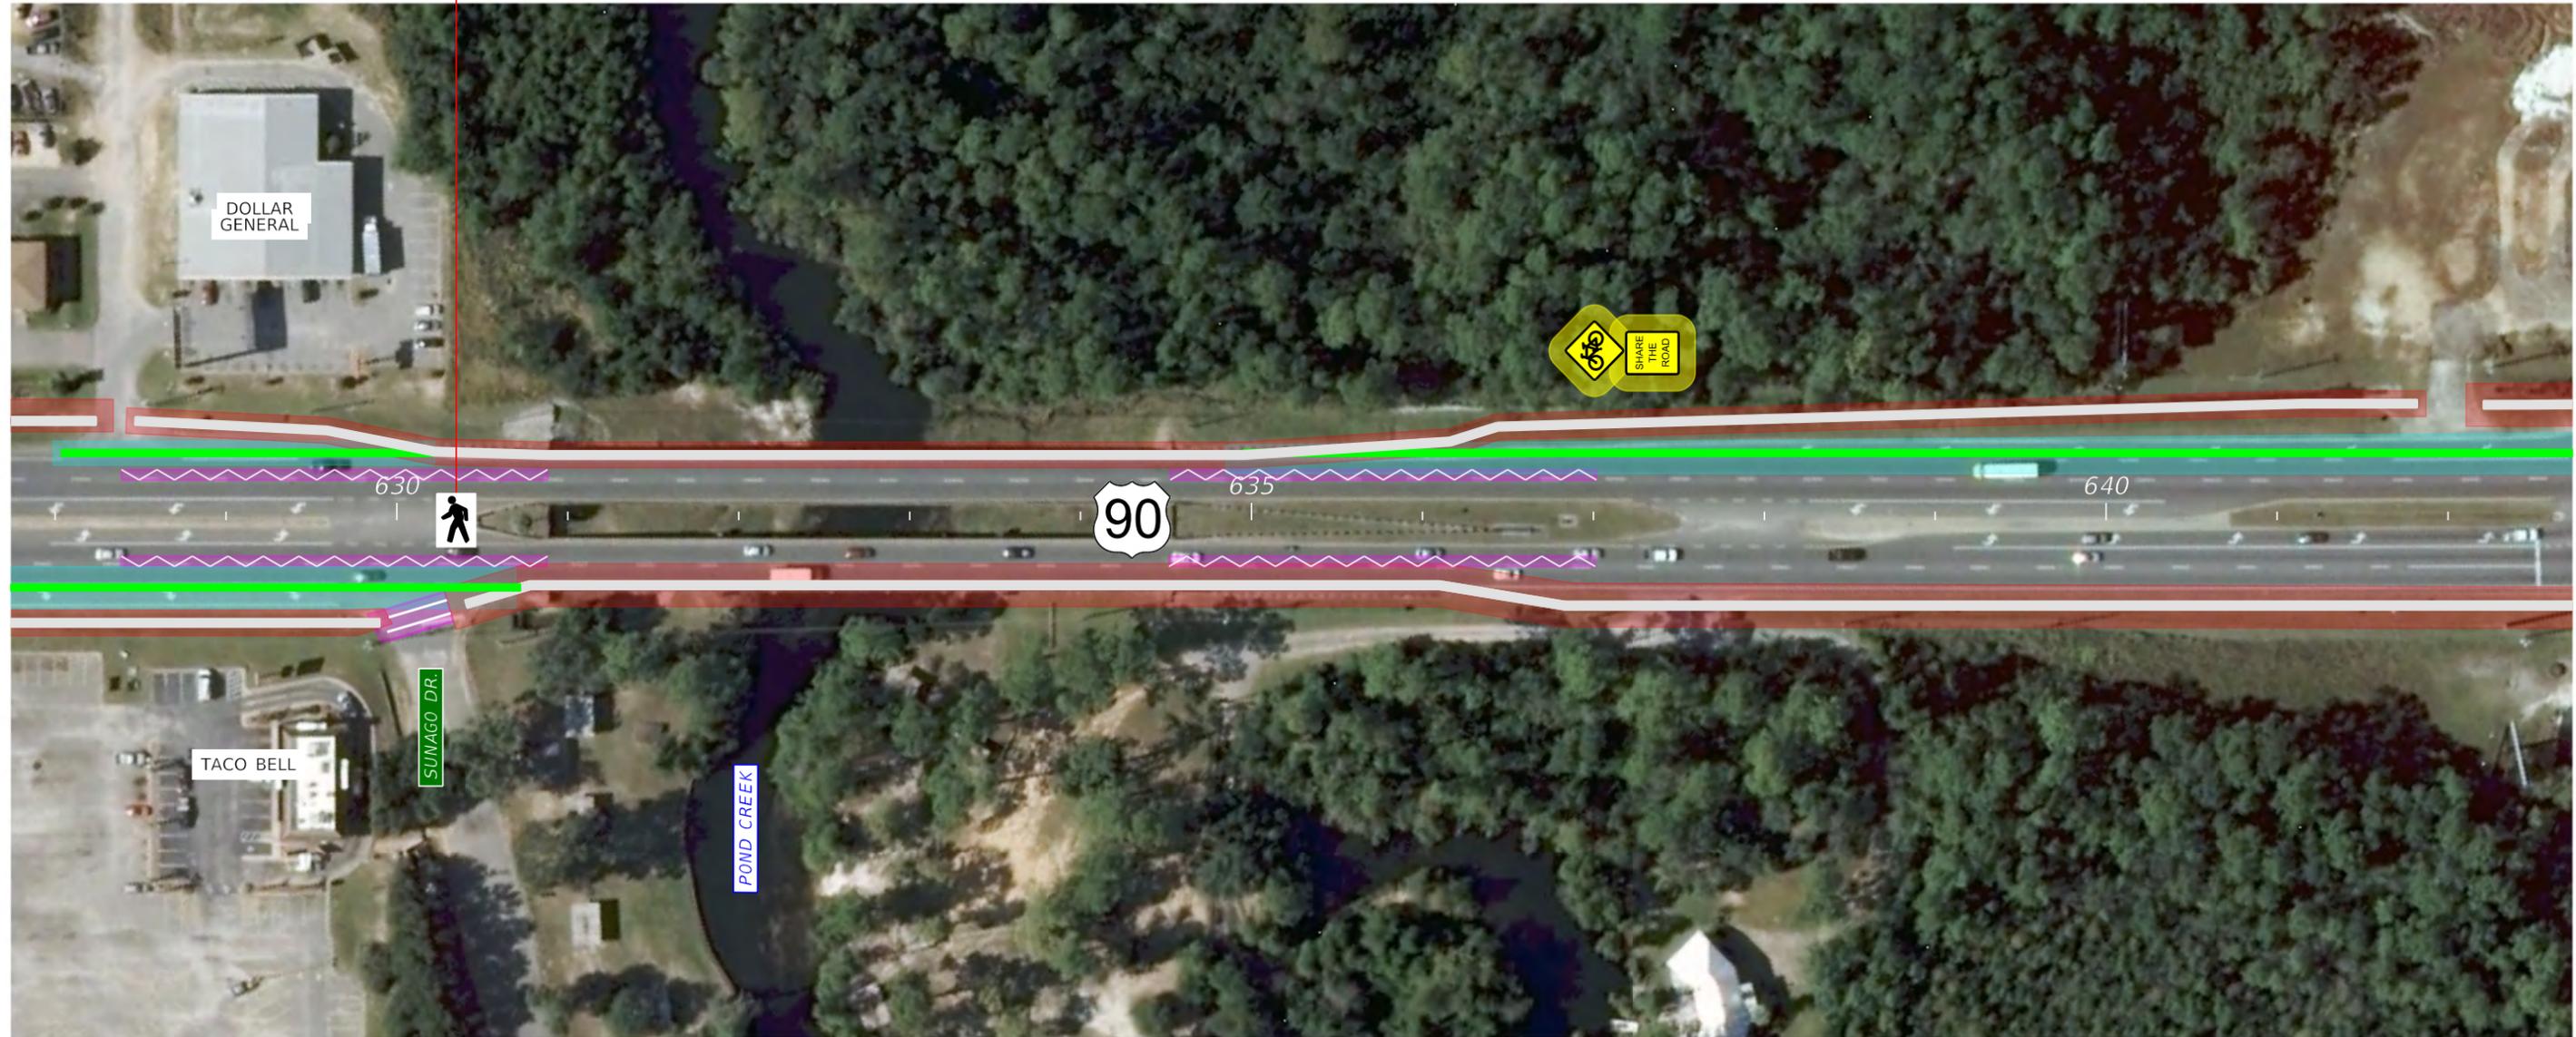
FP2: Intoxicated pedestrian in roadway on Pond Creek Bridge struck by WB vehicles

Pond Creek Bridge. This narrow structure, which connects residential and commercial areas in West Milton, is not suitable for use by pedestrians or bicyclists due to inadequate width and lack of regulatory and/or warning signs. Pedestrians are not provided with a protective safety barrier

from traffic, traveling at least 45 mph on US 90. Signing and pavement markings for bicycles are nonexistent. Although not directly supported by crash history (due to an intoxicated pedestrian fatality), standard pedestrian and bicyclist safety guidelines conflict with the existing bridge crossing conditions. In addition to pedestrians and bicyclists regularly commuting between residential and commercial areas of interest, Mayo Park visitors must cross the bridge from the east side of Pond Creek to utilize the restroom facilities on the west side of the creek.
